Contract #: 04-0120F4Cty: SF/ALA Rte: 80 PM: 13.2/13.9File #: 69.28**WELDING INSPECTION REPORT****Resident Engineer:**Pursell, Gary**Address:** 333 Burma Road**City:** Oakland, CA 94607**Report No:** WIR-002648**Date Inspected:** 16-May-2008**Project Name:** SAS Superstructure**OSM Arrival Time:** 630**Prime Contractor:** American Bridge/Fluor Enterprises, a JV**OSM Departure Time:** 1530**Contractor:** Zhenhua Port Machinery Company, Ltd (ZPMC), Changxing Island **Location:** Shanghai, China**CWI Name:** Sun Wei**CWI Present:** Yes No**Inspected CWI report:** Yes No N/A**Rod Oven in Use:** Yes No N/A**Electrode to specification:** Yes No N/A**Weld Procedures Followed:** Yes No N/A**Qualified Welders:** Yes No N/A**Verified Joint Fit-up:** Yes No N/A**Approved Drawings:** Yes No N/A**Approved WPS:** Yes No N/A**Delayed / Cancelled:** Yes No N/A**Bridge No:** 34-0006**Component:** OBG/Tower**Summary of Items Observed:**

OBG/Tower Sub Assembly**Bay 1 – PMT/Deck Panel Production**

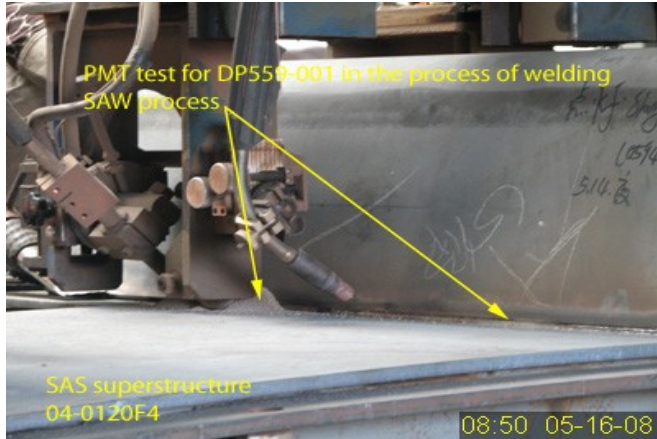
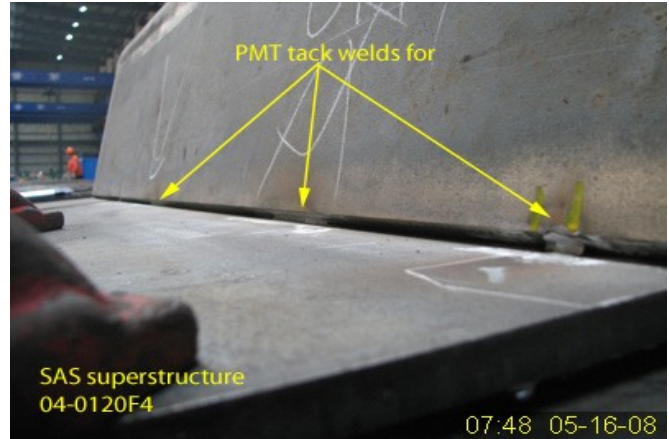
QA Inspector Brannon observed welding utilizing the dual process WPS-B-T-2342-U1 (U-rib)-3 welding procedure specification for closed rib welding of the Production Monitoring Test (PMT) #1 for Production Panel DP559-001 on closed U-rib Partial Joint Penetration (PJP) welds in Bay #1. ZPMC welding personnel performed Gantry Machine, Gas Metal Arc Welding (GMAW) for the root pass and immediately performed Gantry Machine, Submerged Arc Welding (SAW) for the cover/final pass on PMT #1, using gantry machine #1. Upon completion of the SAW pass on U-rib PJP welds on PMT #1 Visual Testing (VT) was performed on weld #1 through #6 by ZPMC personnel and was accepted then VT was verified by the Caltrans QA inspector. Ultrasonic Testing (UT) was then performed by ZPMC inspector and PMT #1 was determined to be acceptable. Macro etch samples were selected by the Caltrans QA inspector on PMT #1.

The following digital photograph below illustrates observation of the activities being performed.
